Silver Dendritic Growth in Plastic IC Packages

Silver dendrites are often found on the die surface of plastic dual-in-line packages after the compound is removed by chemical means. It was initially believed that the silver dendrites were caused by silver migration during moisture stress testing. Further investigations have shown the formation of silver dendrites occurs during the decapping process. Results of decapping experiments are represented, along with a proposed mechanism for the silver dendrite growth.

By Fely N. Lieberman and
Mark A. Brodsky*

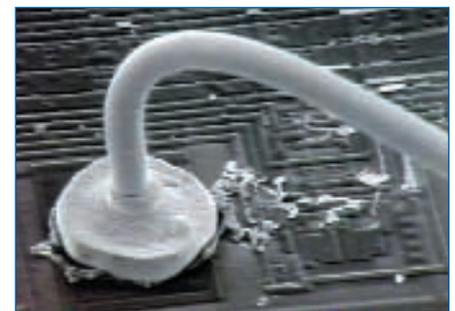
Figure 2. Photo of SEM studies showing the presence of silver dendrites after the decap.

Silver dendrites were found in plastic packages after decapping units which failed moisture stress testing. The size of the dendrites found created doubts that they could have actually grown in an intact package during stress testing.

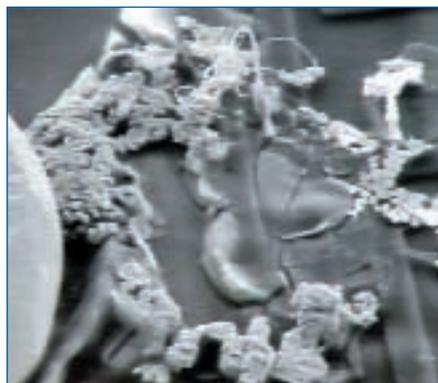
Figure 5 is a photograph of the silver dendrites from Experiment 2 using side-brazed packages. It was noted that the silver dendrites growth nucleated from either the gold ball bond or the rugged surface of the silicon die edge.

Figure 5. Dendrite growth in sidebrazed packaging Experiment 2.

The fuming nitric acid breaks down the silver-filled epoxy. Silver in the presence of nitric acid will form silver nitrate (a liquid) and silver ions. During the acetone rinse, the silver nitrate and silver ions become suspended in solutions.

As the acetone evaporates, a super-saturated silver solutions forms. This provides a condition for silver crystallization to occur at the gold ball bonds and rugged die edges.

The reason for nucleating at the gold ball bond is due to the catalysis effect of gold. Gold, being a transition metal, is a very good catalyst in its reduced form.⁴ Nucleation along the die edges is due to having a rugged or rough site for crystallization to start.
